EIFS: Importance of Proper Installation, Maintenance and Special Hazard Considerations

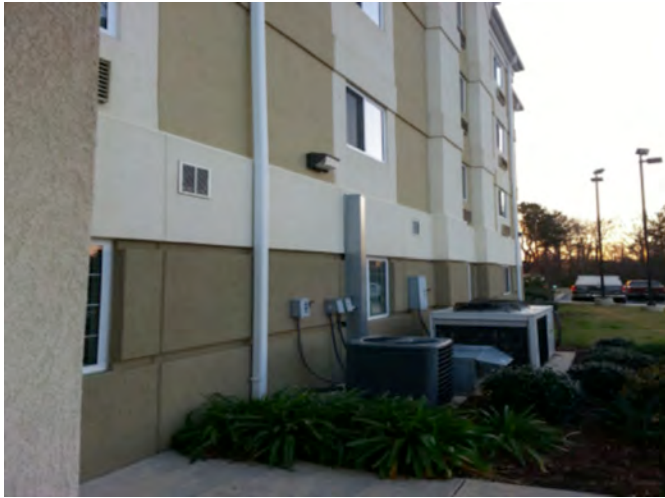
EIFS with multiple corners, edges, windows, joints, penetrations, and wall-mounted AC units.

can quickly become the Achilles heel of the system. Attention to detail is required for the installation of the multiple component materials, adhesives, and fasteners as well as sealing properly around windows, doors, various joints, flashing, corners, edges, ridges, wall-mounted air conditioner units, and wall penetrations. Moisture can be trapped if any of these aspects of installation do not meet the manufacturer’s specifications. EIFS is more complex today than the early forms of this wall system. EIFS contractors are now required to install a multitude of building components with varying designs that necessitate a large amount of installation knowledge, expertise, and precision. Building codes require special installation inspections for EIFS unless it is installed with a moisture barrier and drainage plane, or if the wall is masonry or concrete.

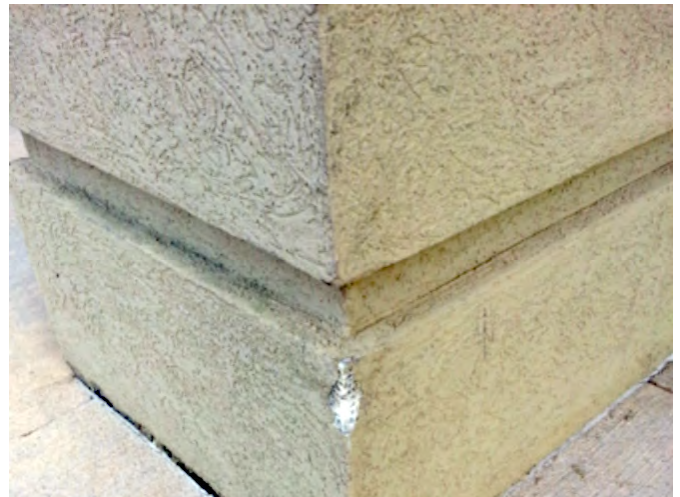
Chipped EIFS with exposed EPS at a hotel entrance near an outdoor smoking area.

Fire is another potential hazard associated with EIFS. The EPS insulation boards that are integral to EIFS have the same composition as Styrofoam cups, and are extremely flammable. Anytime the EPS is exposed, as shown in the photo below depicting a corner section of a building, the potential for fire exists. If an ignition source, such as wildfire embers, sparks from a backyard barbecue or a lit cigarette comes in contact with the EPS, it can ignite a fire within the wall. When EPS burns, it liquefies and spreads very rapidly, which can result in a serious fire within the wall cavity.

One common-sense precaution for structures with EIFS walls is to maintain outdoor smoking sections that are located well away from the building and include adequate ash trays and receptacles. By contrast, it is common for hotels to have smoking areas at their entrances and under porte-cocheres. These areas often have nicked and chipped EIFS due to luggage, carts and deliveries. Building managers should pay special attention to walls with increased hazards. This includes increased periodic visual inspections to ensure there is no exposed EPS, and that proper smoking controls are being followed. Similarly, outdoor grilling should be kept away from EIFS walls so that flames, radiant heat and embers do not come into contact with EIFS walls.
